INSPECTION REPORT

Inspection Date(s):	Friday, February 15, 2019		
Time:	Entry: 12:50 pm	Exit: 1:45 pm	
Media:	Water		
Regulatory Program(s)	CWA NPDES/Construction Stormwater		
Operator Name:	San Manuel Band of Mission Indians		
Sub-Contractor Name:	Sukut Construction		
Project or Site Name:	Eastern Reservation Development		
Facility/Site Physical Location:	34° 8'45.25"N 117°12'42.41"W (<i>construction site entrance</i>)		
(city, state, zip code)	Highland, CA 92346		
County:	San Bernardino		
Geographic Coordinates:	34° 8'45.25"N 117°12'42.41"W (<i>construction site entrance</i>)		
Weather Conditions	Sunny		
Mailing address:	101 Purewater Lane		
(city, state, zip code)	Highland, CA 92346		
County:	San Bernardino		
Facility/Site Contact:	Clifford W. Batten	Environmental Manager	P (909) 425-3590
NPDES Number:	CAR 10I00J		
Indian Country Lands:	San Manuel Reservation		
Receiving Water:	City of San Bernardino MS4		
Facility/Site Personnel Participating in Inspection:

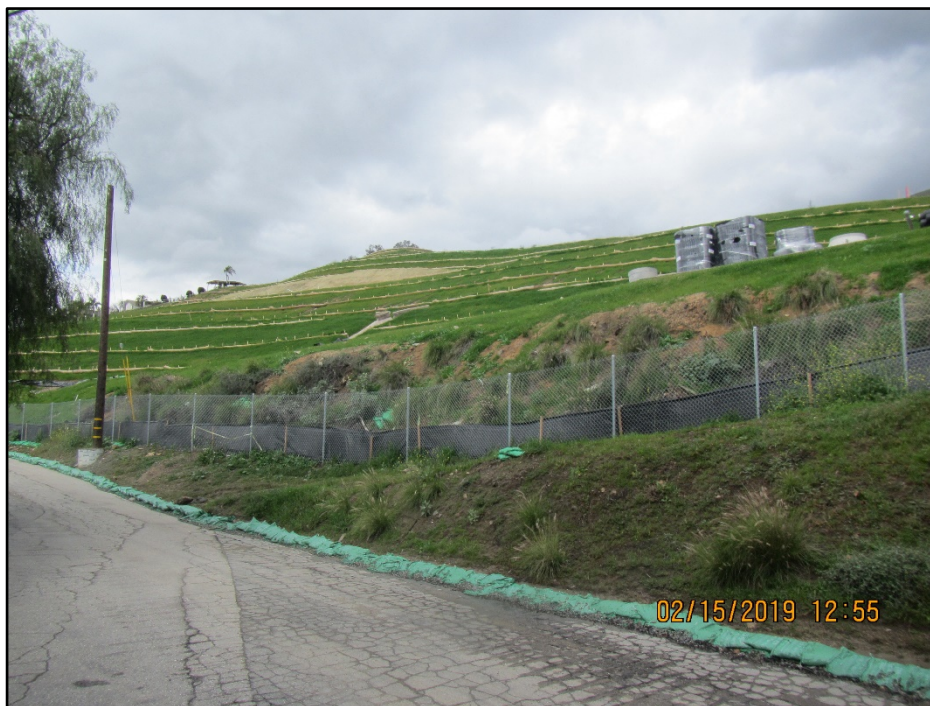
- The Operator installed a silt fence, fiber rolls, and vegetation stabilization measures to reduce soil erosion along the southern terraced slopes of the Project. Silt fencing was installed correctly and ran along the entire southern boundary of the Project. Fiber rolls appeared well maintained and were trenched, staked, and overlapped. Vegetation appeared well established to reduce soil erosion along the terraced slopes (Photographs 1, 5, 6).

Photograph 1: Terraced slopes with vegetation, fiber rolls, and silt fence sediment and erosion control measures to stabilize soils.

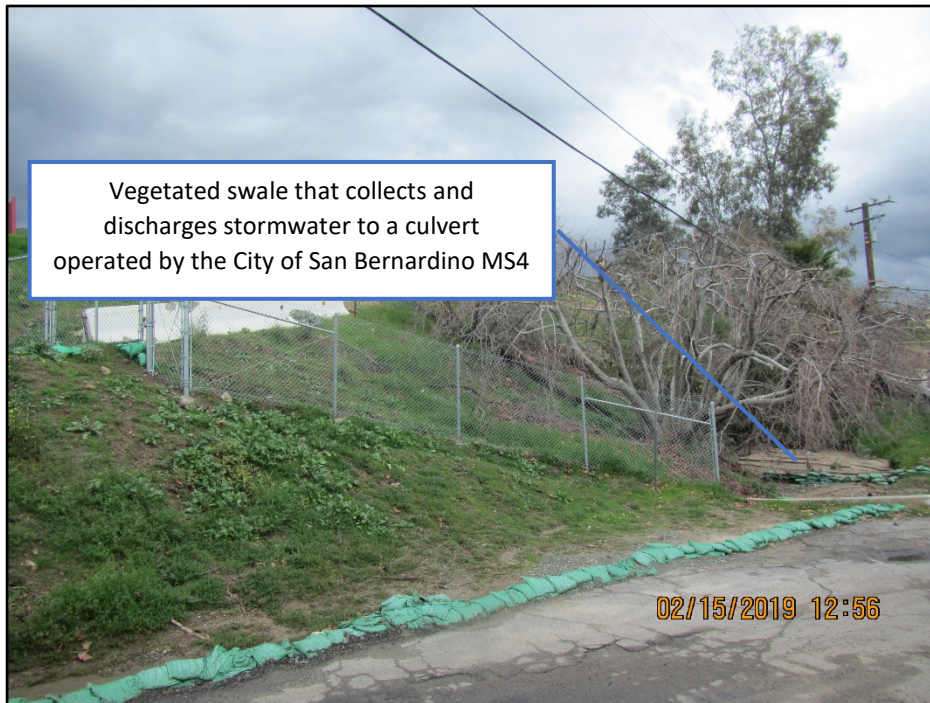
- There was a vegetated swale outside of the Project boundary that receives stormwater run-off from the Project. Sand and gravel bag check dams were located inside the vegetated swale to control the velocity of stormwater during large storm events. Stormwater would enter the swale if water flows over the top of the lower levee, then would flow through a culvert and discharge into the City of San Bernardino's MS4 (Photographs 2, 4).

Photograph 2: Overview of the vegetated swale as seen from Holly Circle Drive, Highland, CA.

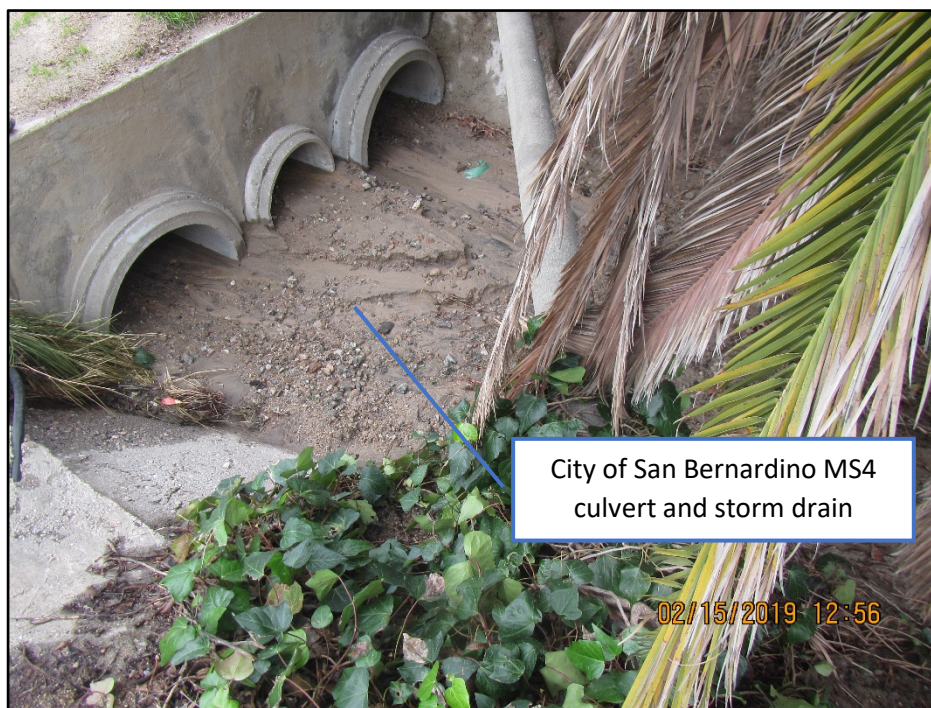
- I noted an unmaintained culvert and storm drain located under Holly Circle Drive, Highland, CA, operated by the City of San Bernardino. Based on the initial citizen complaint, I originally sent an email to the City of San Bernardino on September 24, 2018, asking them to address this ongoing issue (Photograph 3).

- The culvert under Holly Circle Drive should be maintained regularly throughout the year. Google Earth images dating back to April 2012 show sediment build-up inside the culvert under Holly Circle Drive that prevents the flow of stormwater during rain events. My initial maintenance request to the City of San Bernardino was sent via email on September 24, 2018. At the time of the inspection, I observed sediment inside the culvert up to $\frac{3}{4}$ full.

Photograph 3: Close-up of the culvert that runs under Holly Circle Drive. Note: the deposition of sediment from previous rain events.

I requested that the Operator continue to monitor weather conditions, and continue to maintain their BMPs, especially through the rainy season. I reiterated my concern about the overburdened culvert and asked the City of San Bernardino to address the overdue maintenance of their MS4 assets immediately. Lastly, I requested timely attention to the areas of concern outlined in this inspection report and to provide photo documentation of any improvements made to address these concerns.

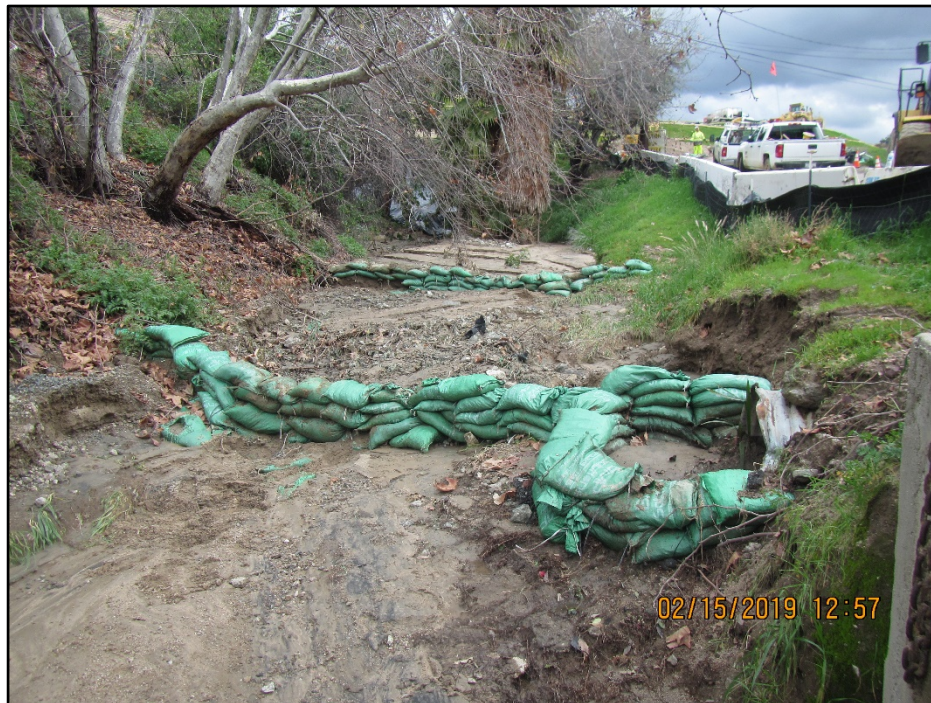
Photograph 4: Close-up of the existing vegetated swale designed to convey and infiltrate stormwater runoff from the area. Note: Sand and gravel bags installed to reduce the velocity of runoff during large storm events.

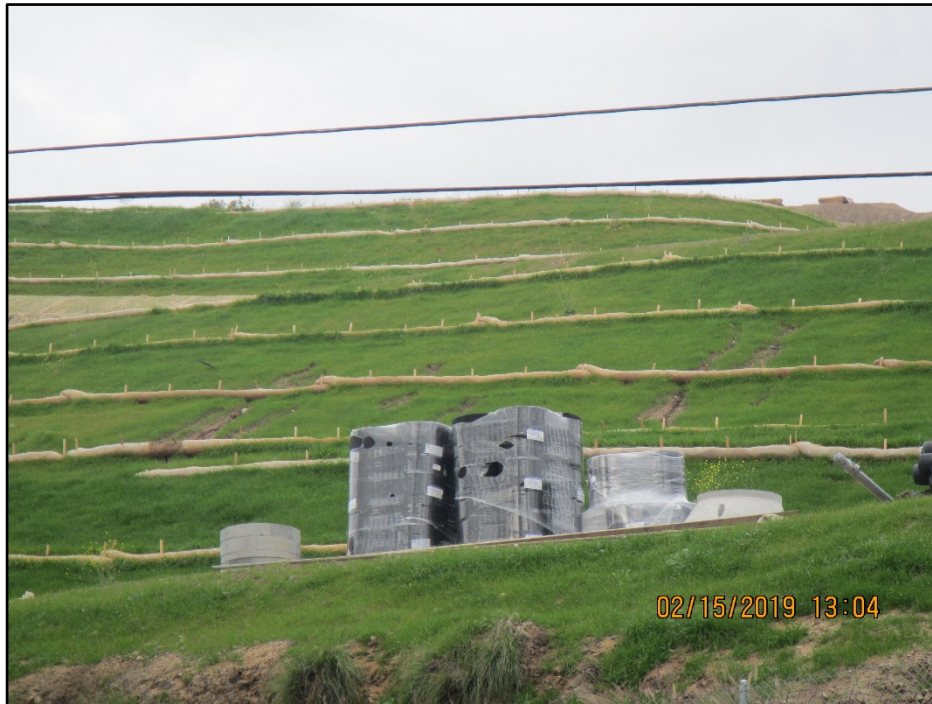
Photograph 5: Close-up of the fiber rolls installed on the southern slopes.

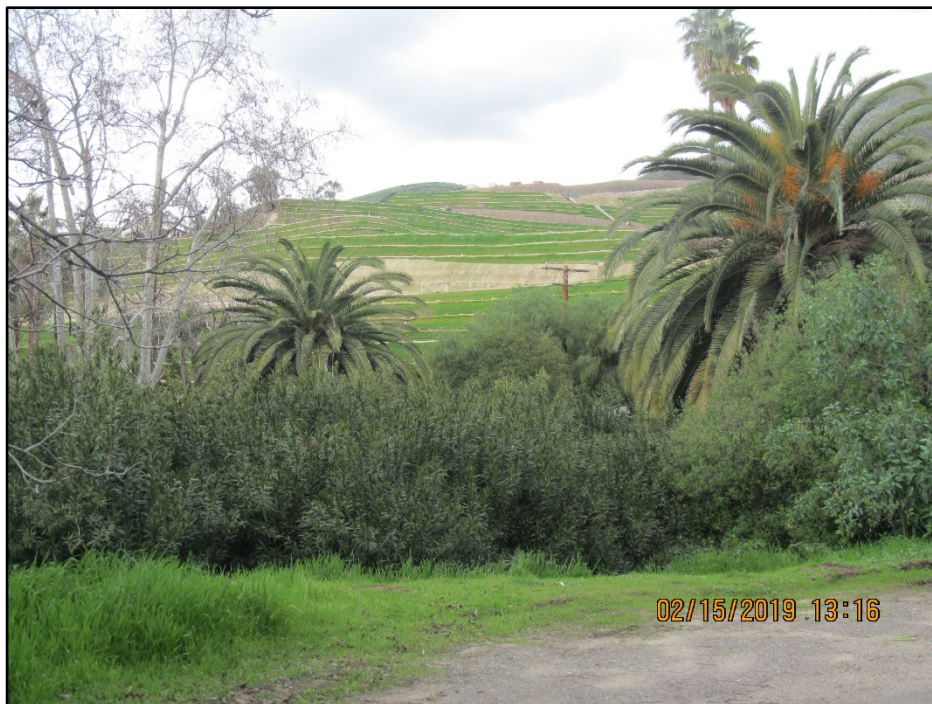
Photograph 6: Macro shot of the Project to show the BMPs installed to stabilize the soils.

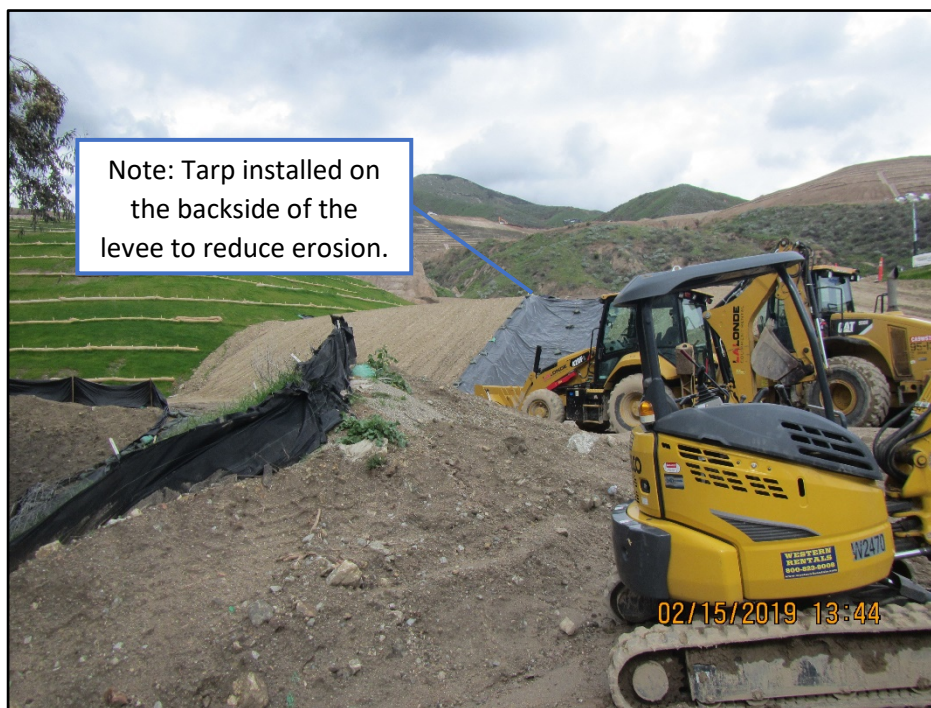
- There were two newly constructed levees installed to reduce the velocity of stormwater into the vegetated swale shown in Photograph 4. Due to recent rain events, there was sediment build up behind the levees. Ms. Crawford stated the sub-contractor will remove and repurpose the sediment as needed around the Project (Photograph 7, 11, 12, 14, 15).

Photograph 7: Backside of the lower levee designed to minimize the volume of runoff and allow sediment to settle before discharging into the vegetated swale.

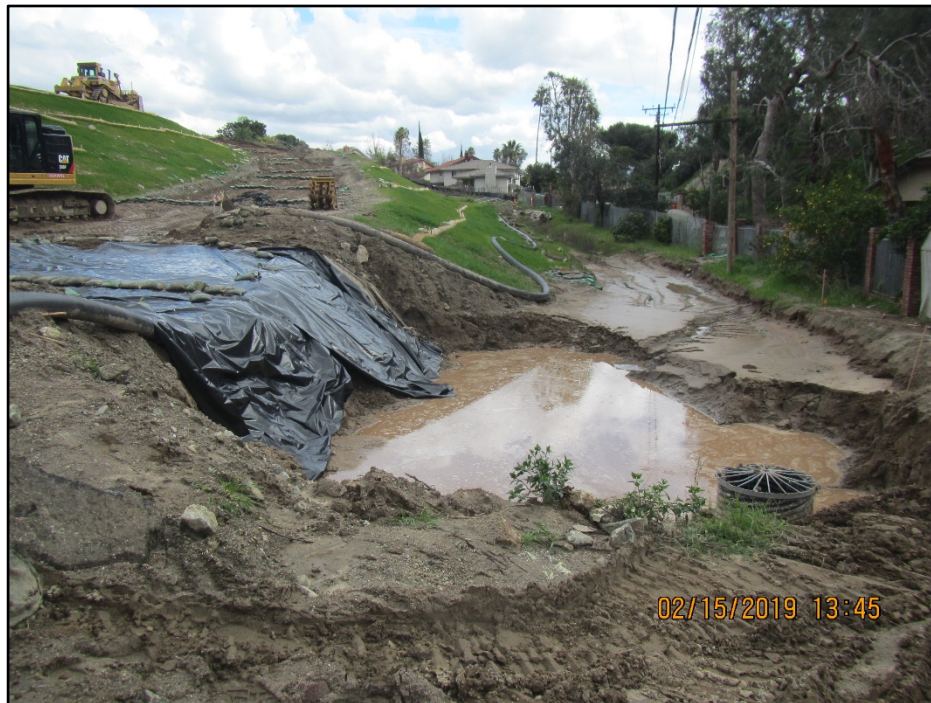
- I observed a flood control channel that runs along the outside boundary of the Project. Although the Project directs stormwater to the two on-site levees, the Operator maintains the area in agreement with the City of San Bernardino. There is a storm drain riser, connected to the City of San Bernardino MS4, located in the channel to relieve the area during rain events (Photograph 8-10).

Photograph 8: Flood control channel that flows along the southern perimeter of the Project. Note: The Operator has an agreement with the City of San Bernardino to maintain the area during the Project.

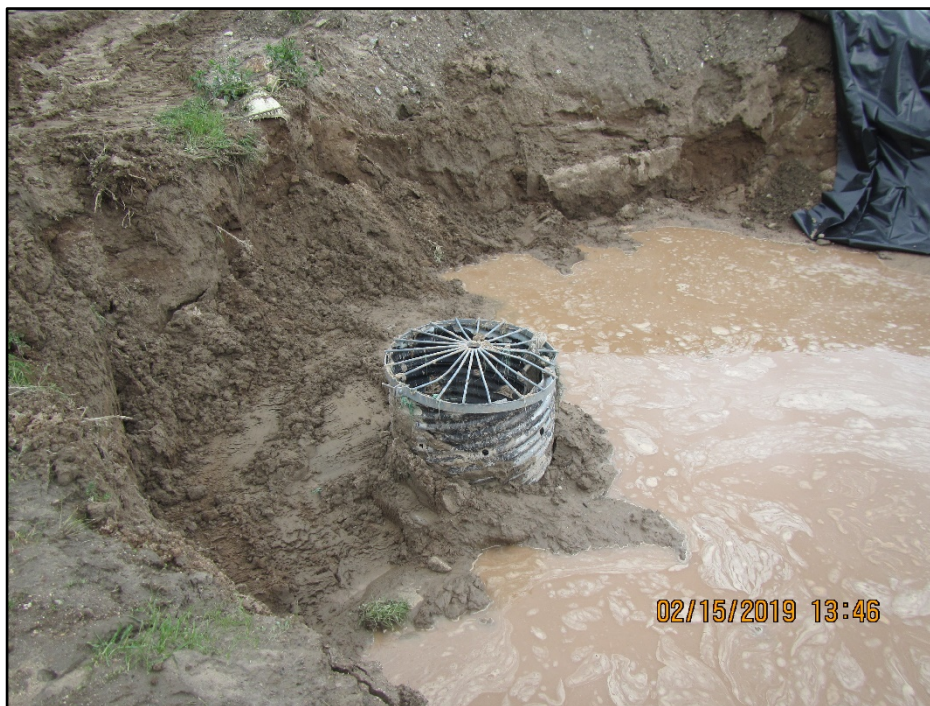
Photograph 9: Close-up of the riser inside the flood control channel.

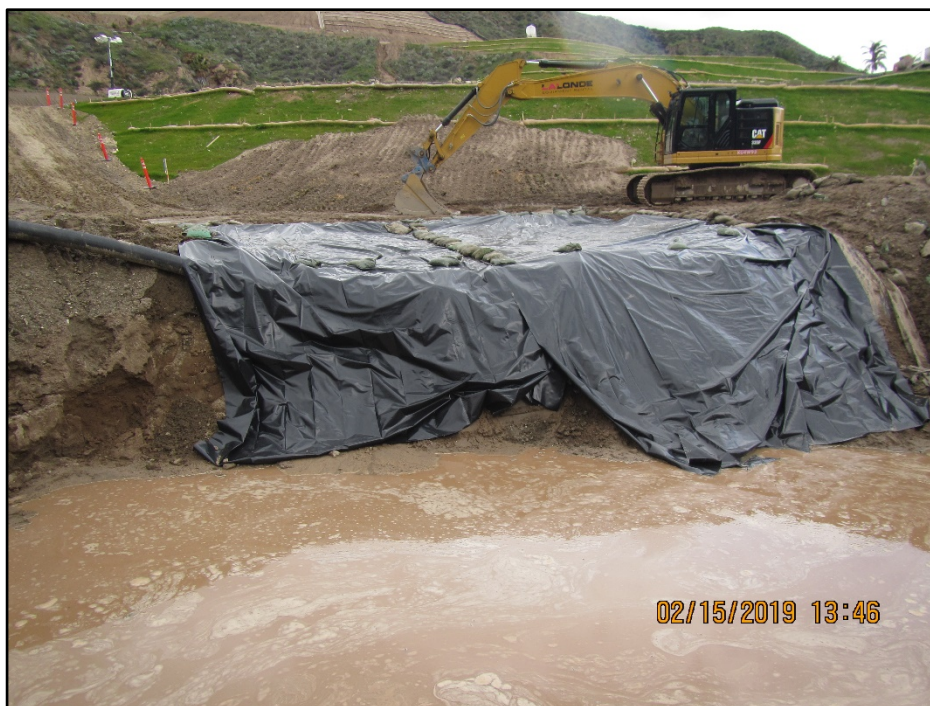
Photograph 10: View of the Project from the flood control channel. Note: The Operator installed a tarp to reduce soil erosion and prevent sediment from entering the channel.

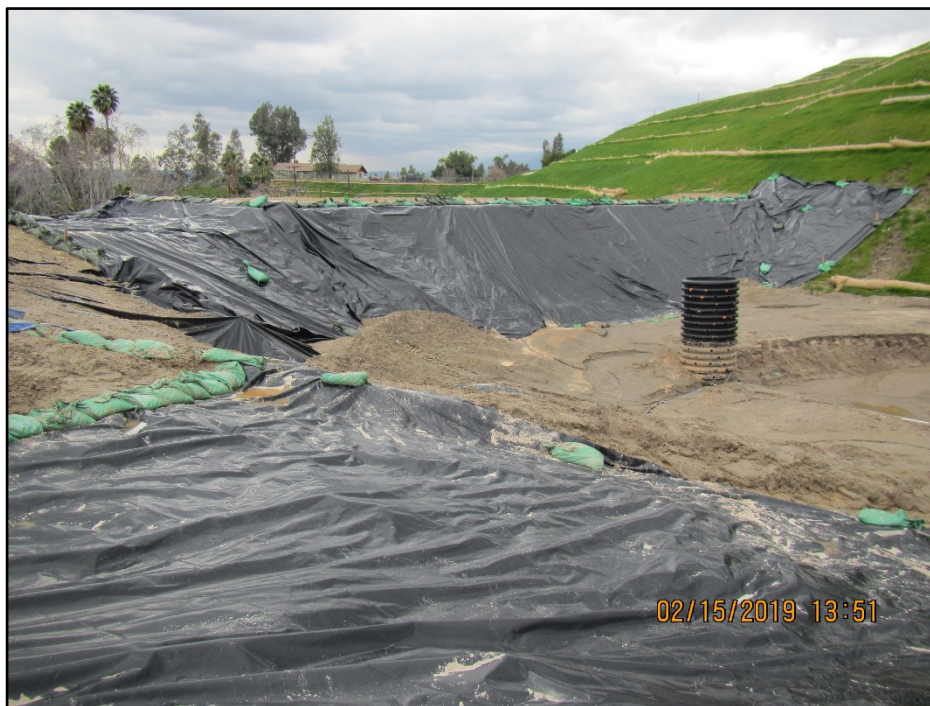
- An accumulation of sediment behind the two levees, particularly the upper levee, from recent rain events. The Operator should maintain these structural BMPs to assure the proper functionality during future rain events.

Photograph 11: Sediment accumulation behind the levee wall. Note: The Operator will maintain the newly-installed BMP throughout the Project.

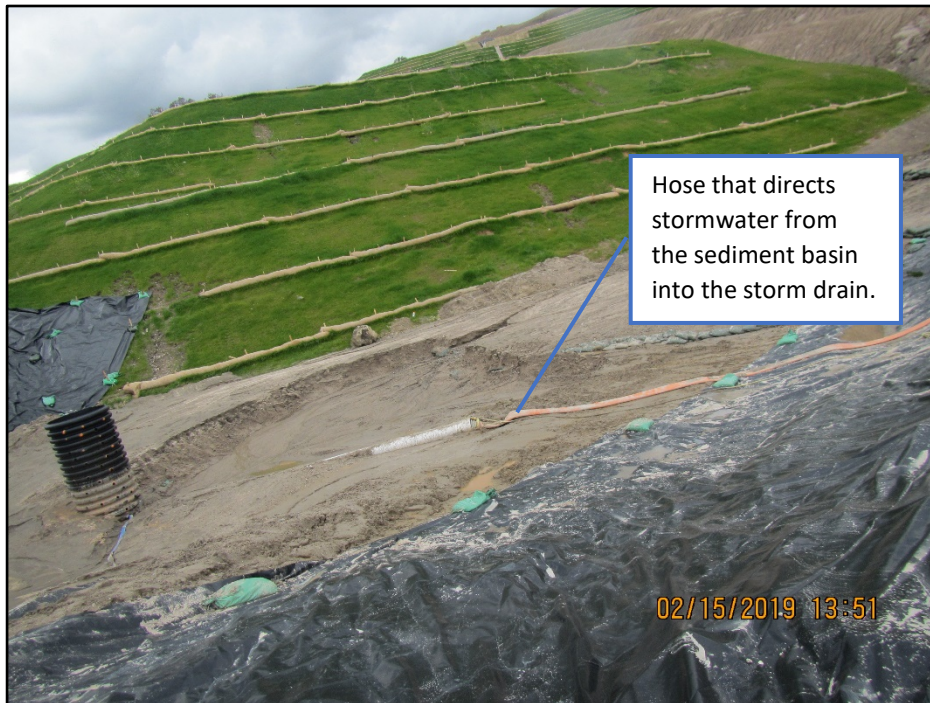
Photograph 12: Photo of the hose that is connected to a pump that directs stormwater from the sediment basin (not pictured) into the storm drain.

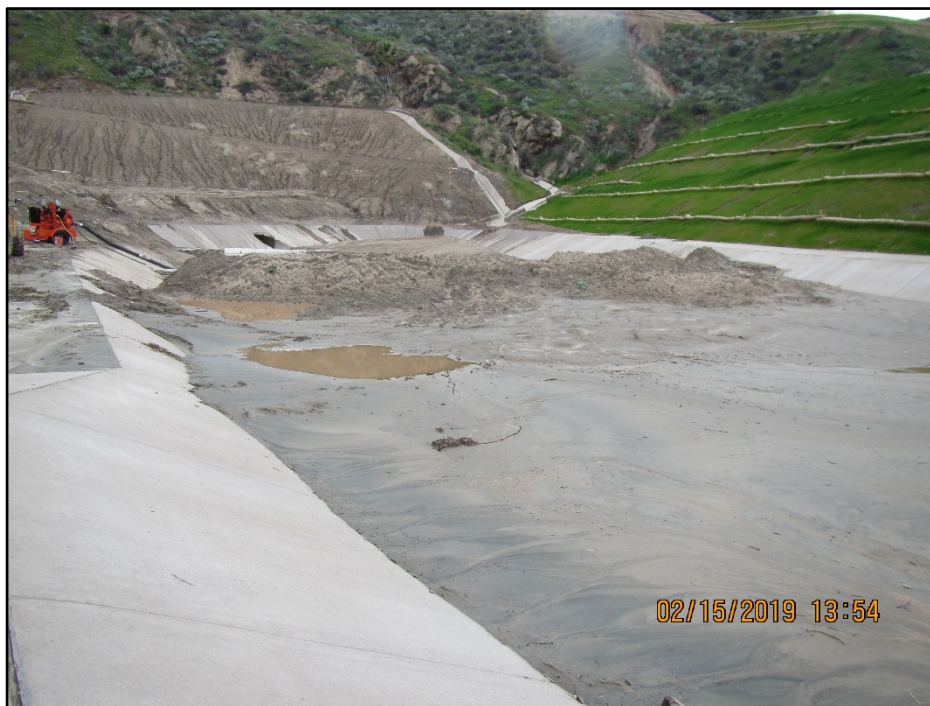
- There is a sediment basin constructed of concrete and installed as a permanent feature located at the toe of the southern slope. The sediment basin collects stormwater via various v-ditches that have been installed throughout the hillside of the project. The basin contained sediment from a recent rain event. Ms. Crawford stated that sediment is removed from the basin and is reused to construct berms and dikes throughout the Project. Water collected in the basin is reused as a dust control measure on-site (Photograph 13, 17).

Photograph 13: Sediment basin designed to collect stormwater from various V-ditches installed throughout the hillside of the Project. Note: Sediment accumulation from recent rain events.

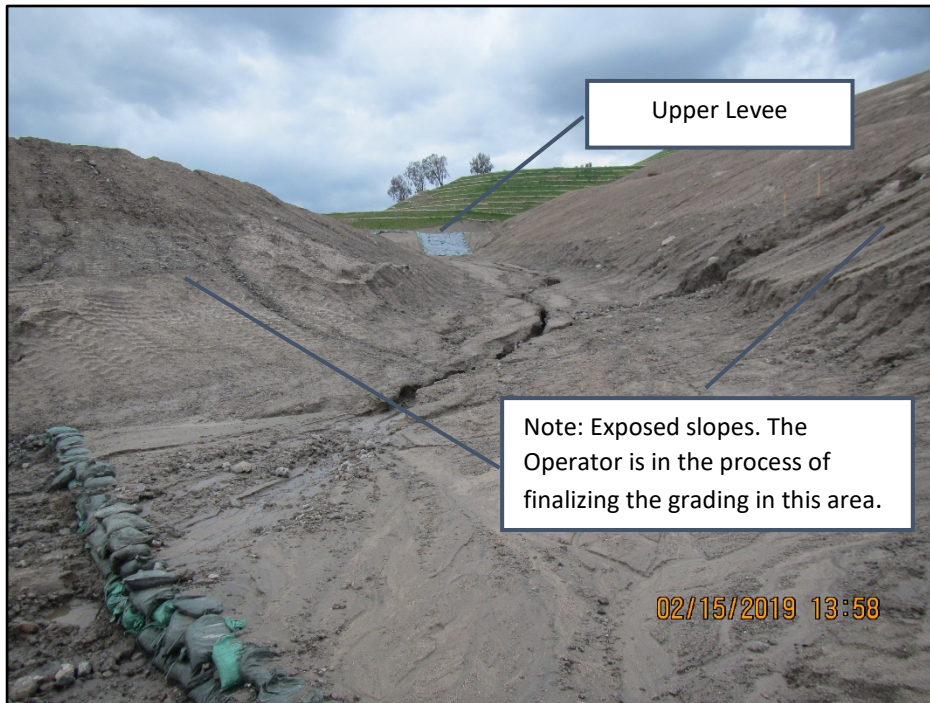
Photograph 14: Backside of the upper levee designed to minimize the volume of runoff and allow sediment to settle before flowing toward the lower levee (not pictured). Note: Sediment accumulation from recent rain events.

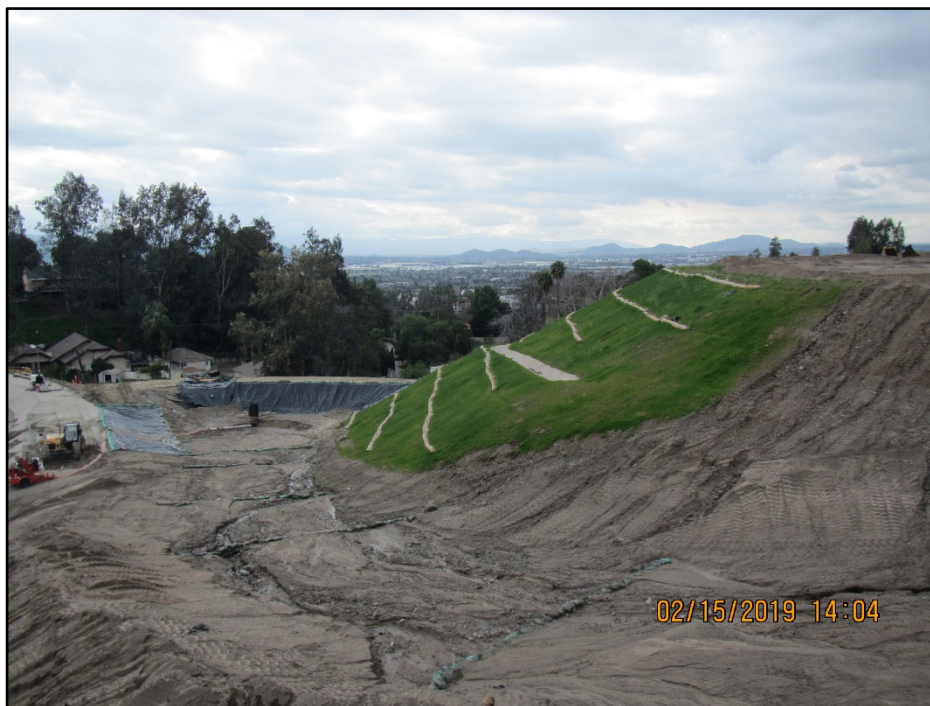
Photograph 15: View of the lower levee as seen from the base of the upper levee.

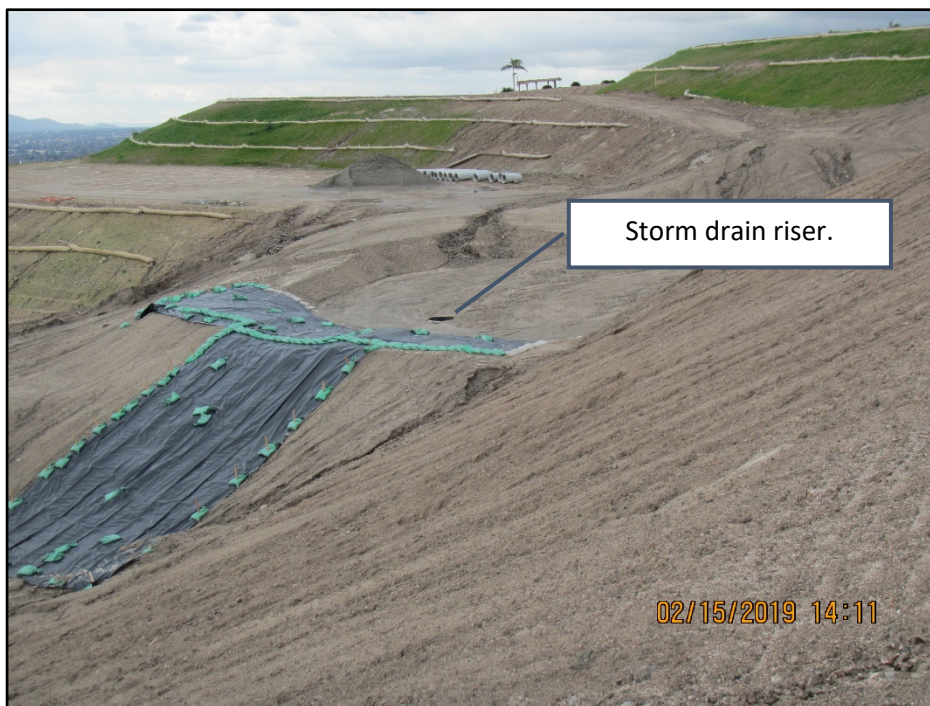
Photograph 16: Overview of the upper levee. The storm drain riser is buried under an accumulation of sediment from recent rain events.

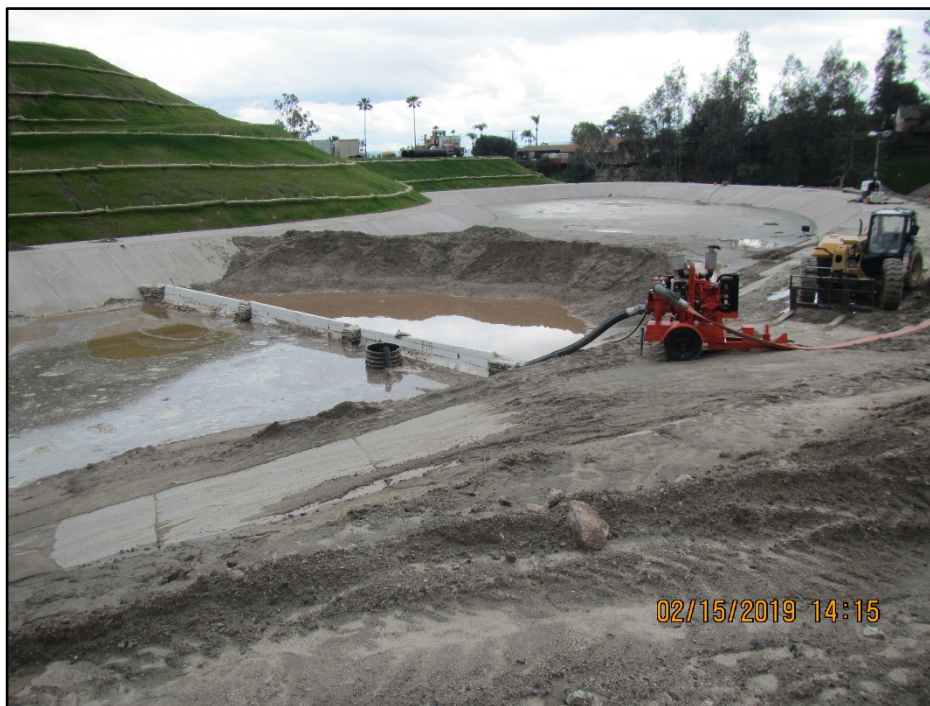
Photograph 17: Overview of the sediment basin located near the base of the Project. Note: The Operator was pumping water from the basin into the storm drain.
